Technical Report Series

Ten Elderly Victims from Intermediate Care Facility Fire Colorado Springs, Colorado

Ten Elderly Victims from Intermediate Care Facility Fire Colorado Springs, Colorado (March 4, 1991)

This is Report 050 of the Major Fires Investigation Project conducted by TriData Corporation under contract EMW-90-C-3338 to the United States Fire Administration, Federal Emergency Management Agency.

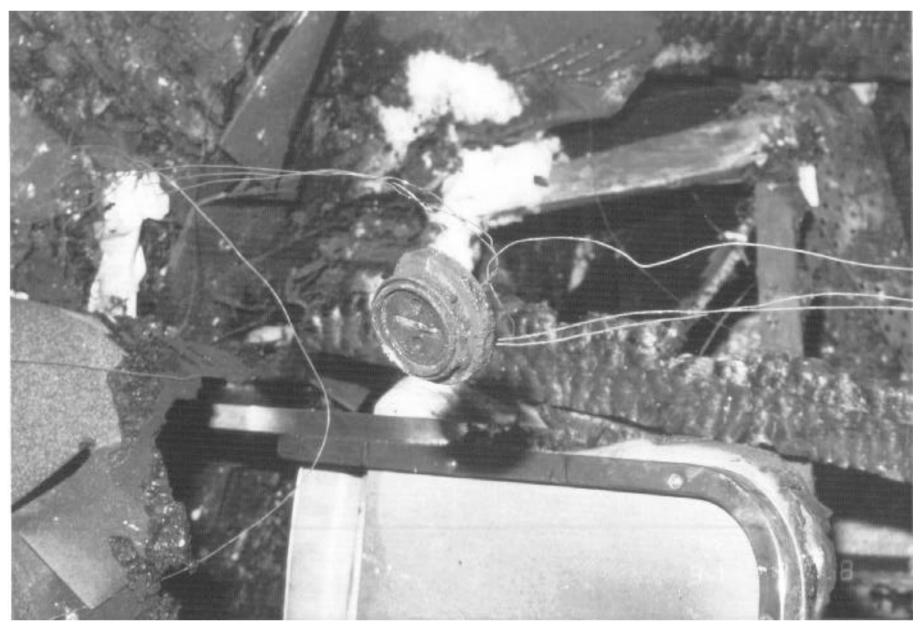
Heat sensors form the attic, either not hooked up or not working as there was no early warning to any panel.

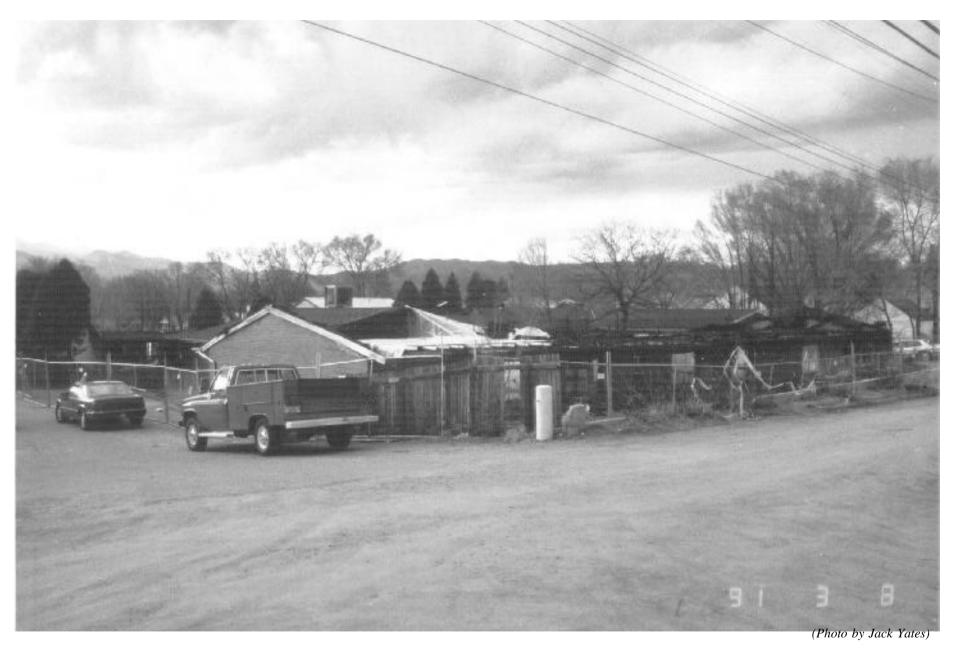
Exterior of the structure as seen from the southeast and looking to the northwest. The east wing is to the right and the south wing is to the left.

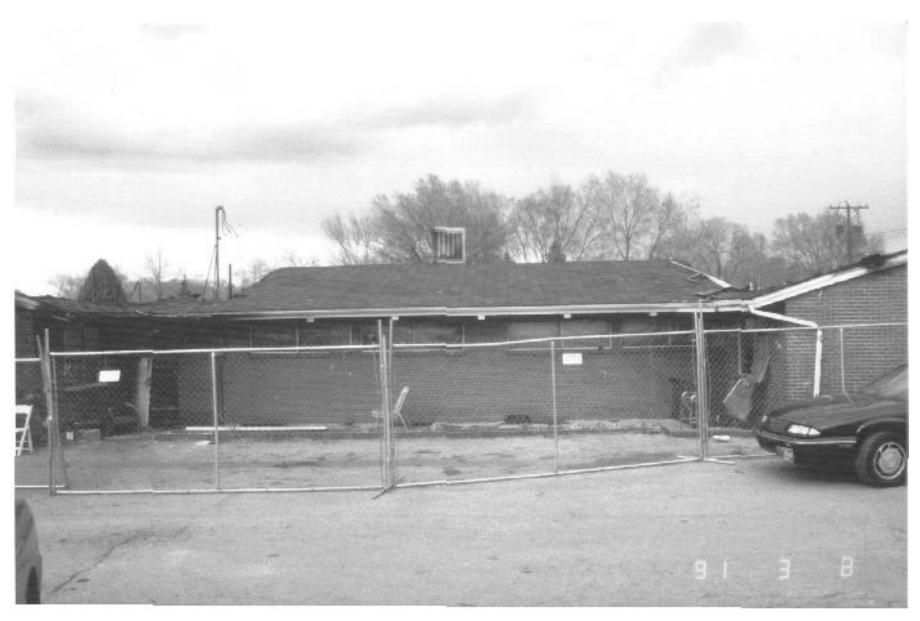
Exterior as viewed from the south and looking north at the wall and roof area over the dining room.

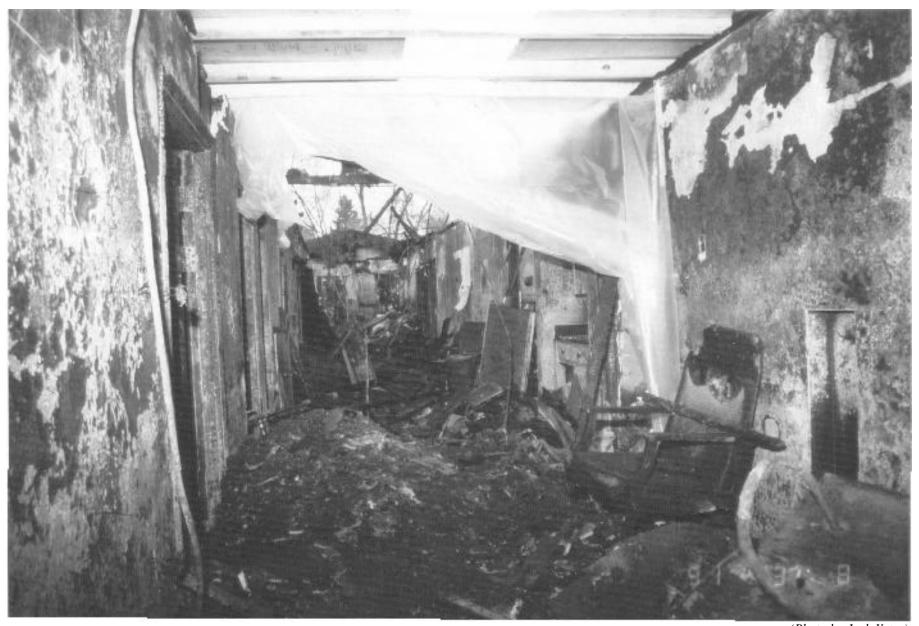
View of the east wing hall as seen from the south to the north. The smoking room where the fire began overhead is the first door on the left.

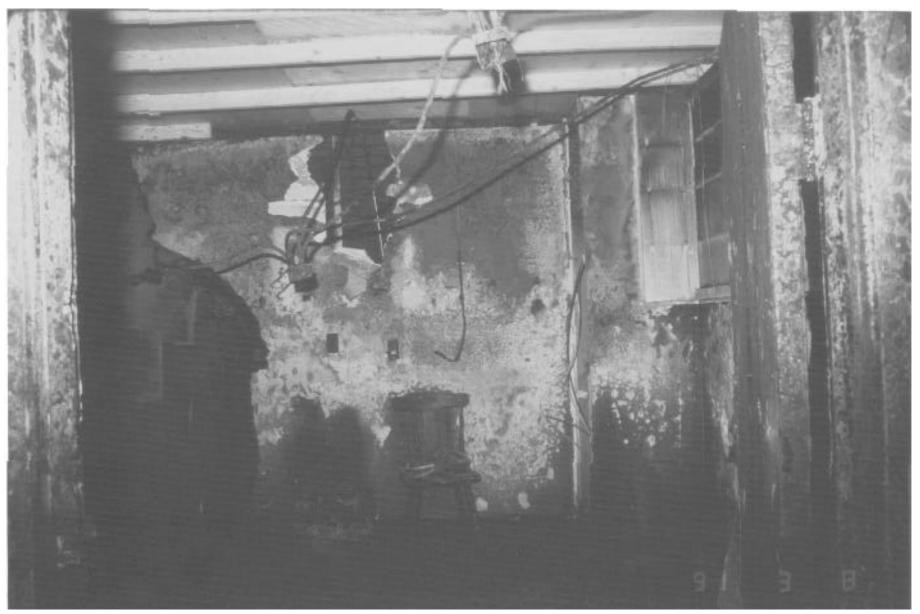
A second area of severe burning was located approximately 8' west of the exhaust fan, at the enclosure to the furnace flue extending from the basement. This flue is immediately next to the extreme east end of the dining room. The top plate surrounding this flue revealed extreme burning on the north side where a support strap

A representative of the National Fire Protection Association, upon viewing the two areas of burn, theorized that the fire burned deeply near the flue because the enclosure was open and unrestricted from the basement to the attic. This permitted a sustained flow of fresh air into the attic at this point, which allowed very hot, and efficient, burning to take place.

The smoking room. The corner to the right is the northwest corner where the vent stack to the heating unit below is located. This was thought originally to be the Area of Origin.

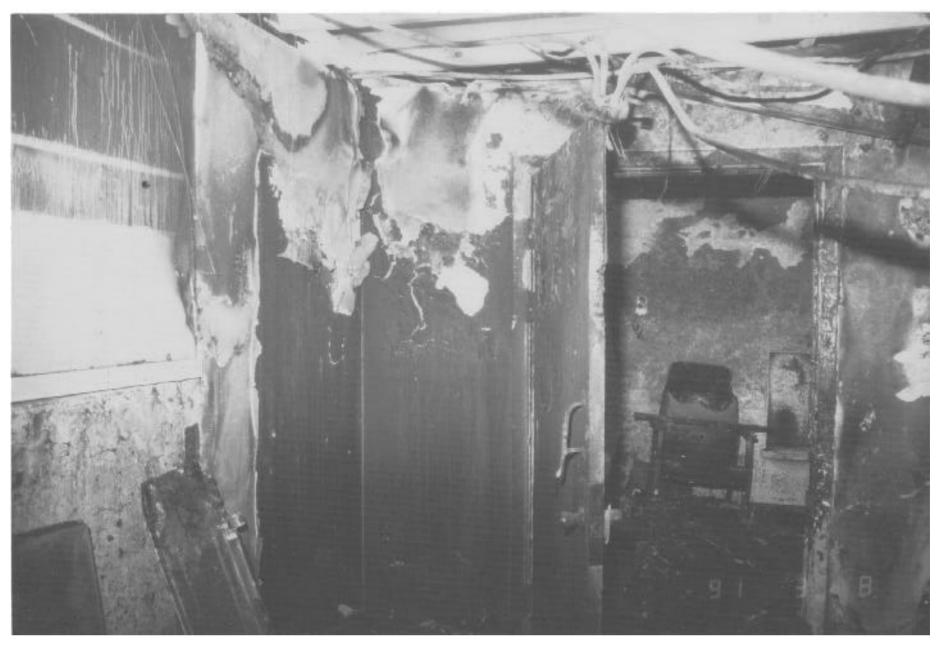
A "consumer grade" 110 volt ceiling exhaust fan, similar to that found in residential bathrooms, was recovered from the debris in the smoking room. An employee informed investigators that the ceiling fan was controlled by the overhead lighting and was very noisy. She also said the fan was present when the building was purchased by the current owners.

Closer inspection revealed that the bearing assembly to the fan showed evidence of extreme wear, with the bearing/bushing being worn into an oblong shape. An owner later stated that approximately 1 month before the fire, the exhaust fan became very noisy so someone removed the fan cover and sprayed WD-40 into the motor housing. This reduced the amount of noise the fan made.

View of the northeast corner of the smoking room. The light switch behind the door (just under the white spot in the center) controlled the fluorescent lights and the ventilation fan. The fan was located in the northeast corner. When the lights were on the fan was on. Since the switch location was difficult to get to, the lights and fan stayed on for hours and sometimes days at a time.

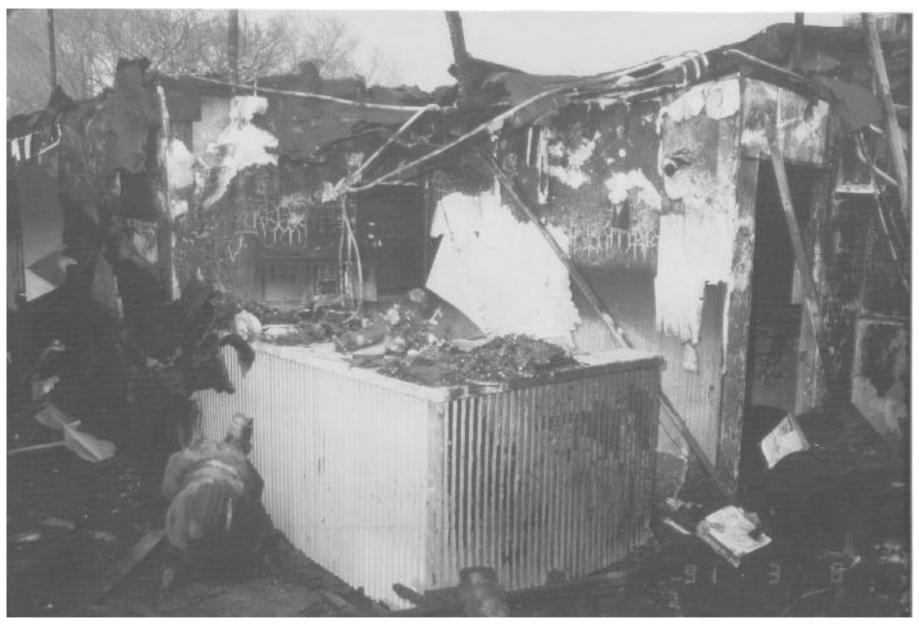
It is unknown why the heat detectors found in the attic area of the east wing did not warn of the fire in that area. Inspection of the alarm panel revealed 2 fuses which were blown at some unknown time. The condition of the system before the fire has not been established.

Nurses' station just inside the front (southwest) door. The alarm panel is at this station. View is toward the northeast.

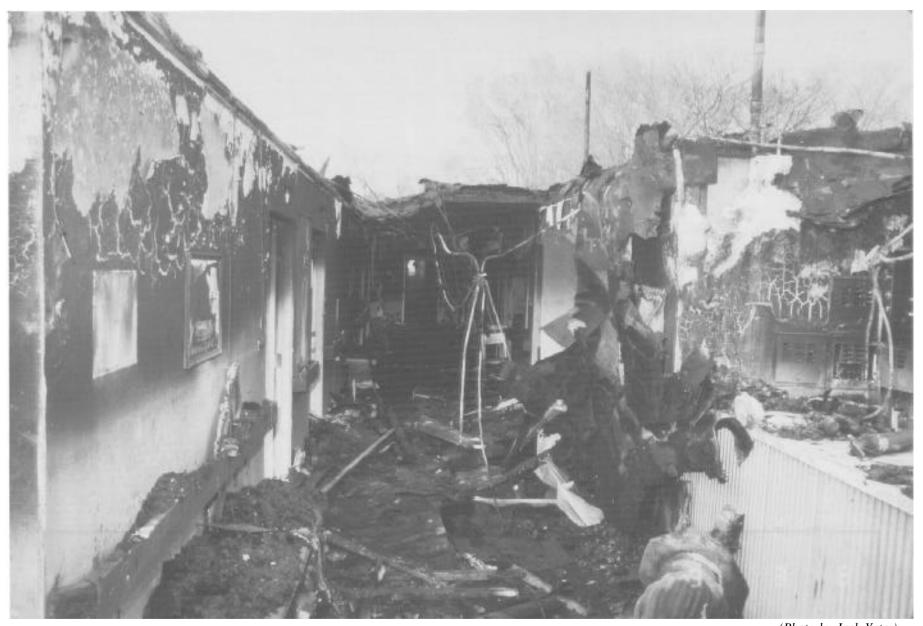
Looking north from the entry area by the nurses' station down the hall. Note all overhead framing was destroyed.

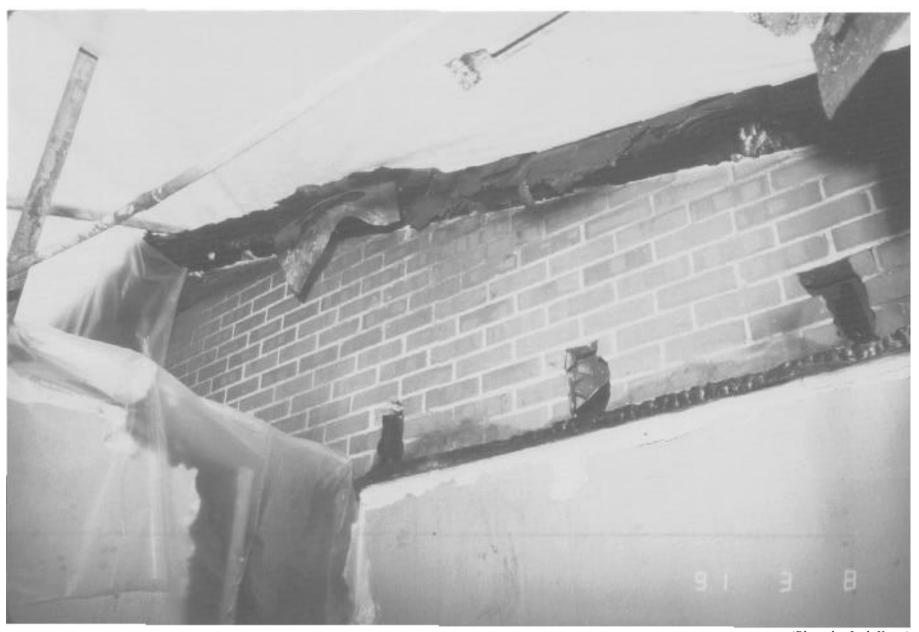
However, the actual structure did not have safety features that originally were thought to be there; in particular, properly rated and designed firewalls. A wall at the east end of the dining area was thought at first to be a firewall, however, closer inspection revealed that a tongue-in-groove ceiling extended over the top leaving exposed wood to the outside. A cinder block wall was constructed adjacent to it, but the integrity of the wall was breached when holes were punched in in order to allow the ceiling joist for the east addition.

The east wall of the dining area. Note where holes have been punched in to put joists through. There was a cinder block wall behind this, but tongue-in-groove boards extended over the top exposing the boards to the brick area. Integrity of the firewall was breached from the holes and overlap of wood material.

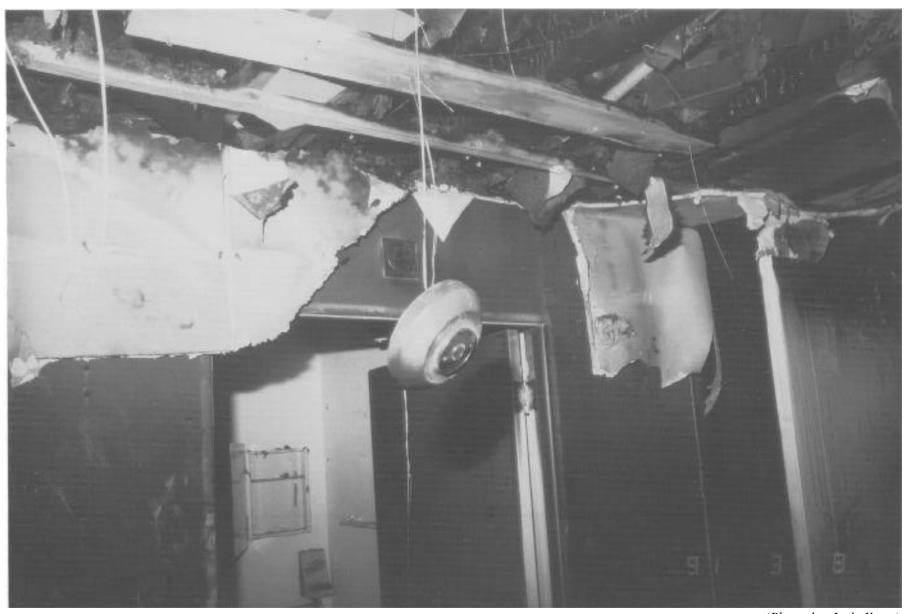
It also appeared all systems were hard wired and were not battery backed.

Older existing smoke alarm in the structure, hard-wired, no battery backup.

All detection equipment in place must be kept in working condition. The system must be checked on a scheduled basis by trained personnel. Battery assistance to hard wired heat/smoke detectors offers the greatest safety. Although not a factor in this loss, the scenario of this incident illustrates the threat of loss of power.
